Monitoring Completed Navigation Projects Program

Greenville Bridge Reach, Bendway Weirs

Final report

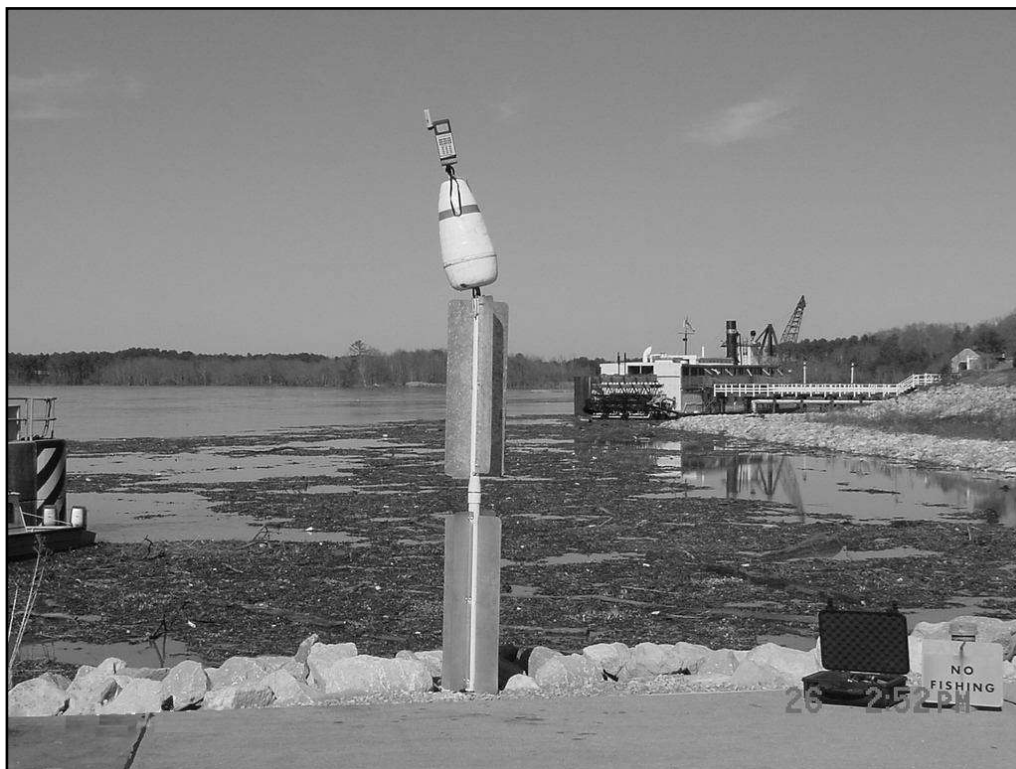
Figure 3. Float with two sections configured to draft 8 ft (after Winkler and Wooley 2002).

A float was designed to accept a GPS unit mounted near its top to reduce any interference to the signals from the GPS satellites. The float was constructed in 4-ft sections so the depth of the float could be adjusted to either a 4-ft or 8-ft draft by screwing the two sections together (Figure 3). The float was constructed of 3-in.-diam PVC pipe attached to a 12-in.-diam high density Styrofoam buoy. Four sheet metal fins were mounted to the PVC pipe to increase the effective area of the float. The 6-in. sheet metal fins increased the resistance of the float, ensuring that the float would

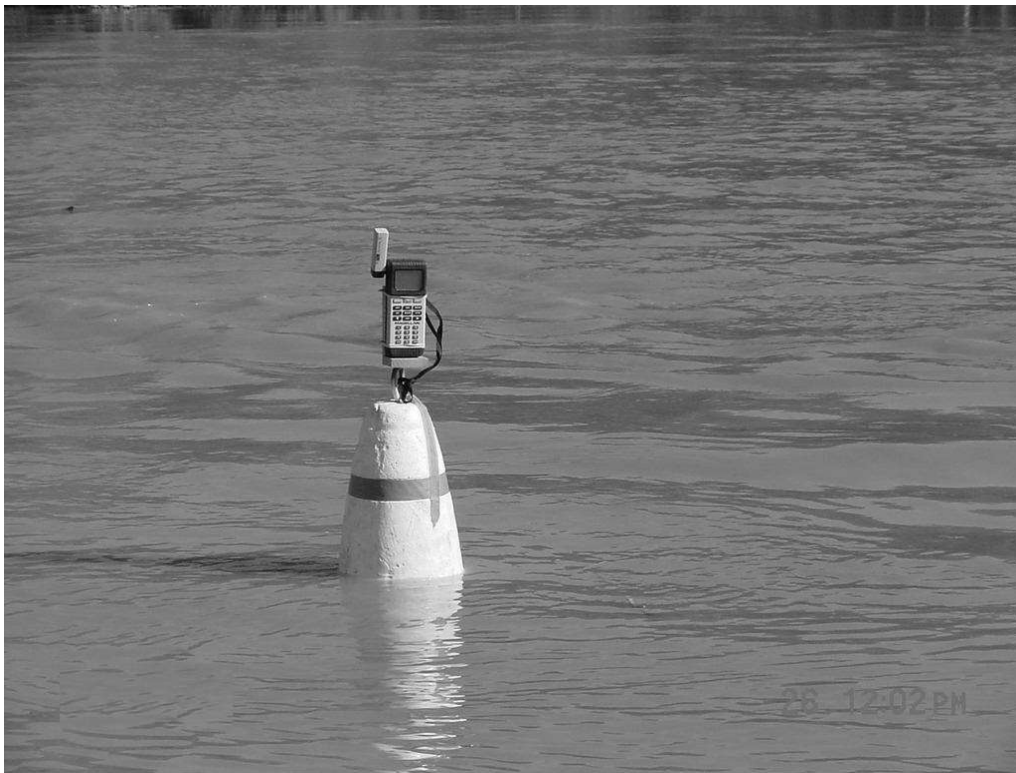
Figure 4. Float with GPS receiver mounted on top standing vertical in the water (after Winkler and Wooley 2002).

move at the speed of the current. The metal fins also increased the weight of the float to make it stand vertical in the water column (Figure 4).

The GPS receiver was mounted near the top of the buoy to minimize any interference with the GPS antenna. Mounting the GPS receiver to the buoy also minimized the risk of losing the receiver if the bottom section of the float was snagged on an underwater object and broke free. A two-man crew per boat was required to drop, track, and retrieve the float. The boat operator positioned the boat at the drop site, while the second crewmember turned on the GPS receiver and placed the float over the side. Two floats were used but a separate boat tracked each float. Experience with floats in large rivers has shown that floats dropped close together sometimes will separate by moving apart or one moving at a different speed making it difficult or impossible for one boat to keep track of two floats. Also, for safety reasons and protection of the floats, it was better to have two boats dropping floats in case one boat stalled at a critical time. The tracking boat stayed close enough to the float in case it needed to be retrieved due to tow traffic without interfering with the currents affecting the float.

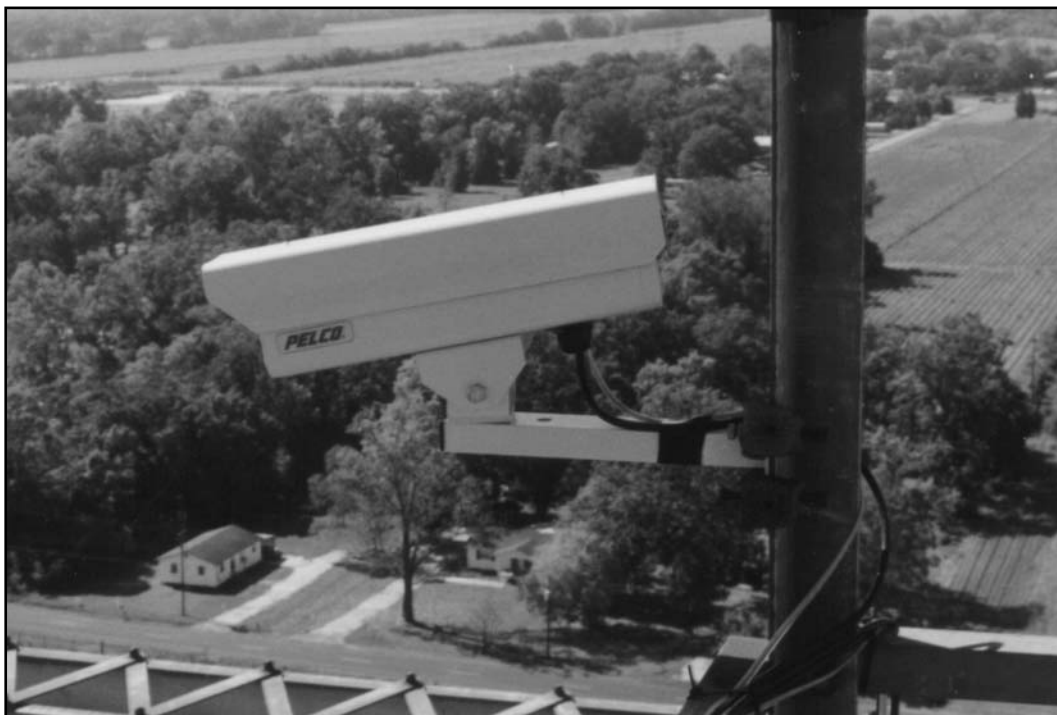
Figure 6. Video camera in weatherproof case (after Winkler et al. 2003).

A high quality camera was selected to provide clear, crisp pictures for analyses. A Sony Color Video Camera model SSC-CX34/34P was selected for the project. The SSC-CX34/34P camera is compact, lightweight and has a 12-power zoom lens with automatic iris. A camera without a zoom lens could have been used but the zoom lens allowed better compositions of the target area without repositioning the camera. The automatic iris was essential for adjusting the iris to changing light conditions in the field. The camera was mounted in a weatherproof camera case with a mount that allowed some rotation for aligning/positioning the camera (Figure 6). In extreme weather conditions, the camera case could be outfitted with heat strips and/or a fan to control the temperature inside the case. The SSC-CX34/34P camera operated on 24-volt alternating current and, therefore, required a transformer that was installed in the recorder box.
